CITY OF SIOUX FALLS
FALLS PARK, SOUTH DAKOTA
DECEMBER 10, 2018

VISIT DATE	October 29, 2018
CONTACT/TITLE	Karen Leonard, Deputy City Attorney
LOCATION VISITED	Falls Park in Sioux Falls, South Dakota

My primary objective was to visit Falls Park located in Sioux Falls, South Dakota and provide an independent review of the drowning risk associated with Big Sioux River and Falls which pass through the park.

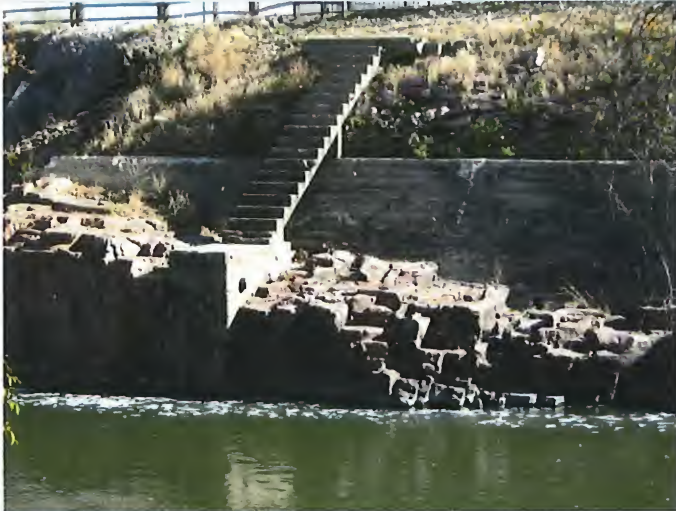
Pic #1

This area represents a potential "attractive nuisance" to Falls Café patrons and the existing wooden fence appears to be easily by-passed by adults, minors, and young children.

Stairs (historical) just North of Low Head Dam, East bank of river

2018-3	<p>Extend the metal vertical guard railing beyond its current point to further mitigate access to the area along the East bank of the river, which includes the single set of concrete stairs that are North of the low head dam. These stairs were indicated to have historical significance.</p>

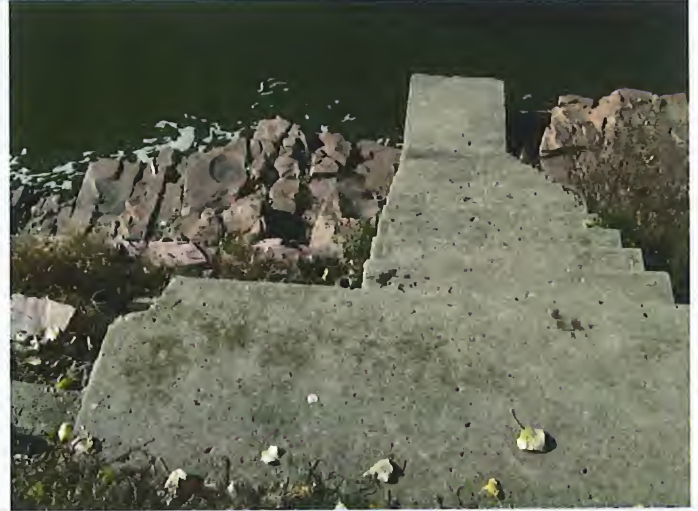
Pic #2

Stairs (historical) just North of Low Head Dam, East bank

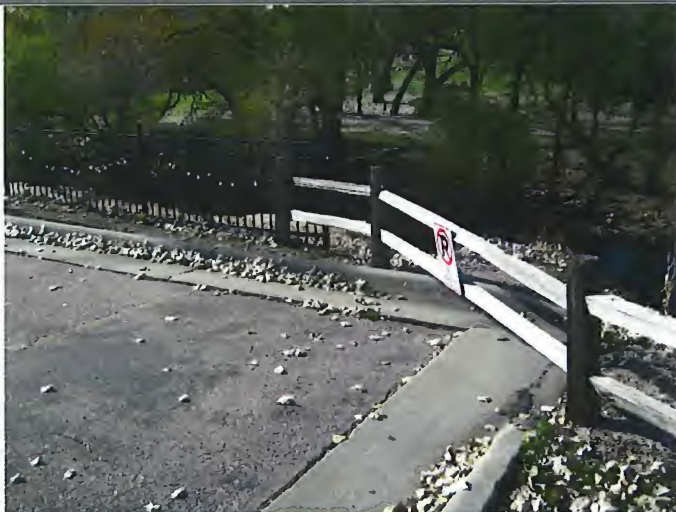
Pic #3

Fencing by Stairs, East side of River

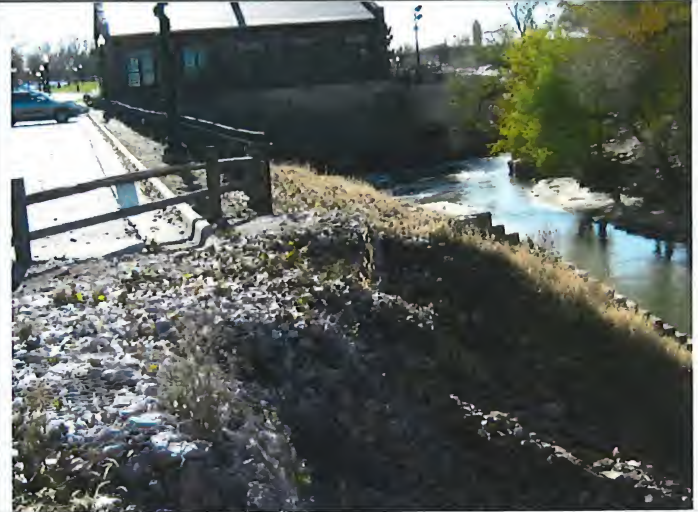
Pic #4

Fencing by Stairs, East side of River

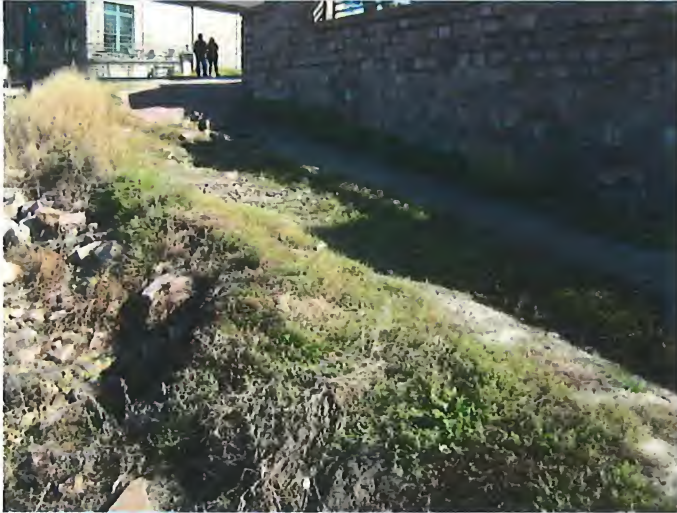
Pic #5

Path leading down to slippery rocks, East bank of river

Rec #	Recommendation Details
2018-1	<p>Consider making the sandy path along the East river bank less accessible to visitors.</p> <p>This sandy path allows easy access to a large grouping of river rocks made slippery from the mist of the falls. The path was observed to be frequently traveled by visitors, even though a viewing platform was readily available in the immediate vicinity.</p> <p>Possible solutions could include extending the existing metal guard railing, or positioning large boulders or other natural barriers to maintain the park aesthetics while still providing a safeguard to this area.</p> <p>Reference pictures below #5-8</p>
2018-2	<p>Further eliminate access to the rock formation that juts out into the river from the existing viewing platform to reduce the possibility of visitors slipping and falling from potential moisture caused by rain, sleet, or snowfall combined with the steep angle of the rock formation.</p> <p>This could be accomplished by extending the existing guard railing to close the gap between railing and the viewing platform. The rock formation and viewing platform are located on the West bank of the river.</p> <p>Reference pictures below # 9-10</p>

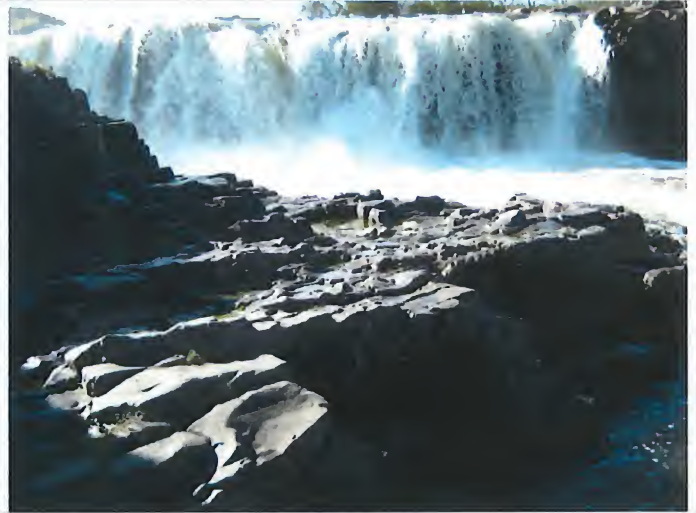
Pic #6

Slippery Rocks, East bank of River

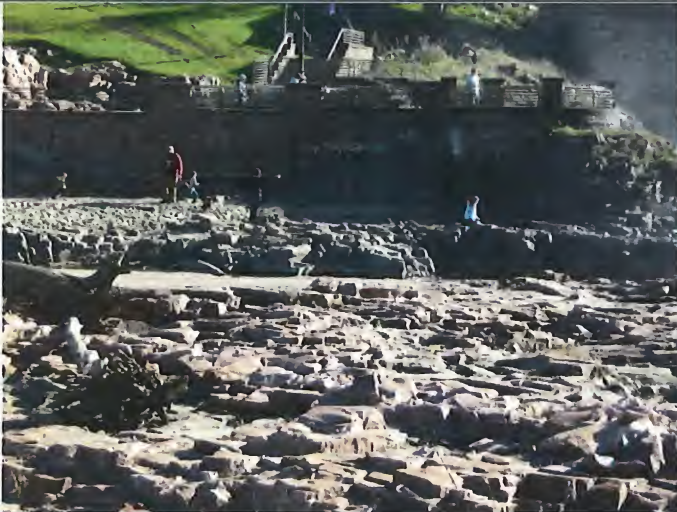
Pic #7

Slippery rocks past sandy path, East bank of river

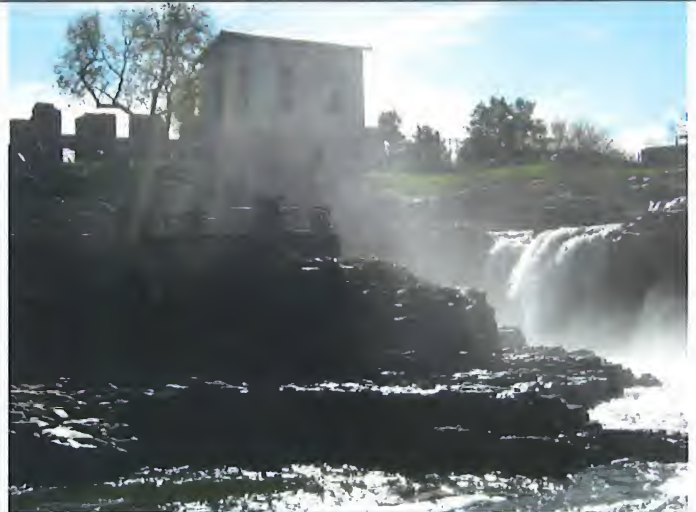
Pic #8

Slippery rocks past sandy path, East bank of river

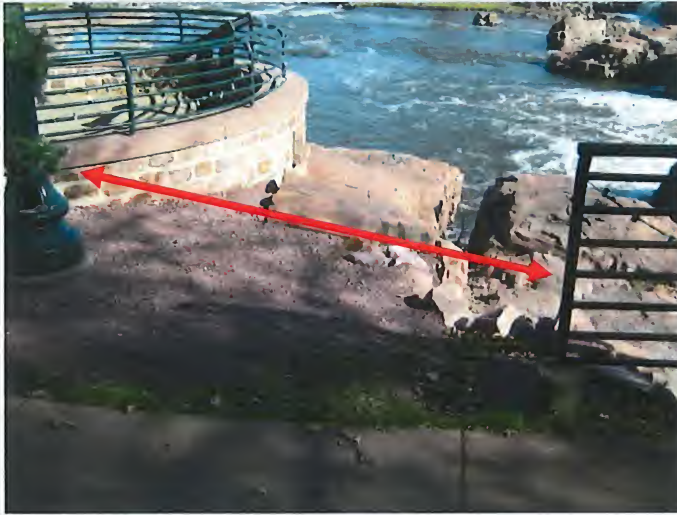
Pic #9

Gap between existing railing and platform, West bank of River

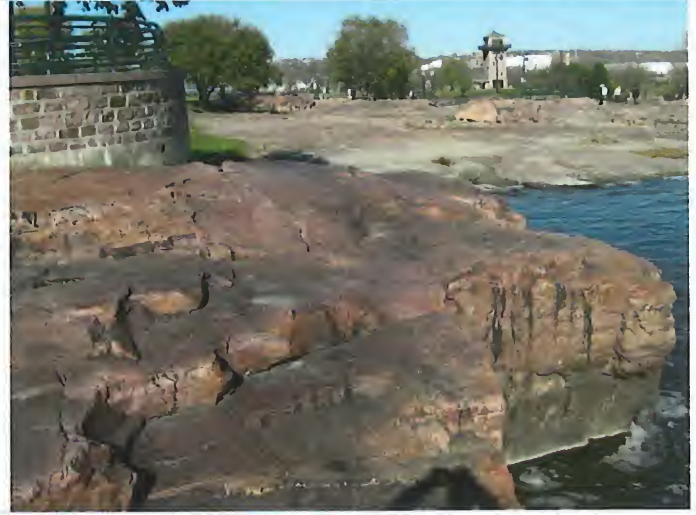
Pic #10

Rocks beyond gap between railing and platform, West bank of River
